## **NATIONAL TRANSPORTATION SAFETY BOARD**

### **Weather Study**

ERA17FA181

Location: Near Eleuthera, Bahamas  
Date: May 15, 2017  
Time: 1339 eastern daylight time  
1739 Coordinated Universal Time (UTC)  
Airplane: MU-2B, registration: N220N

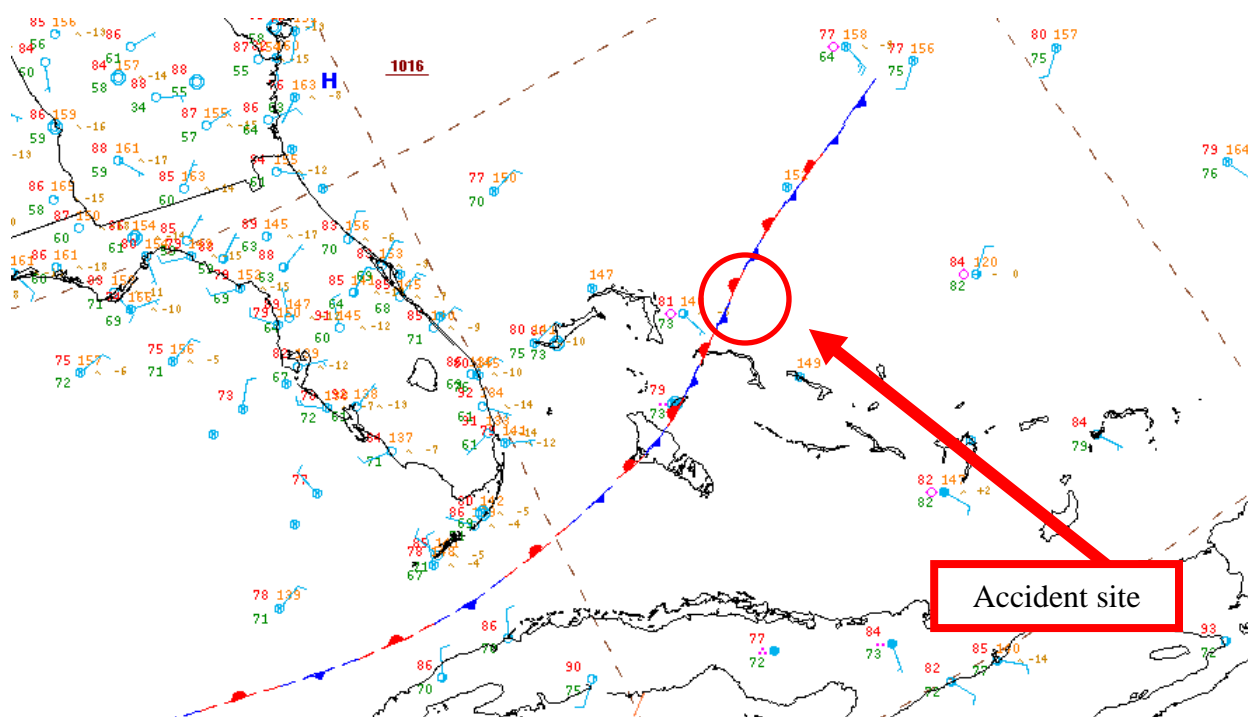
The NWS Surface Analysis Chart for 1400 EDT is provided as figure 1 with the approximate location of the accident site marked within the red circle. The chart depicted a stationary front located in the eastern Gulf of Mexico stretching eastward into the northwestern Atlantic Ocean with the accident site located directly coincident with the stationary front. A surface high pressure system was located in the northwestern Atlantic Ocean near the coast of Georgia and South Carolina with a pressure of 1016-hectopascals (hPa). The station models around the accident site depicted air temperatures in the upper 70's to lower 80's degrees Fahrenheit (°F), dew point temperatures in the low 70's °F, variable winds under 5 knots, and mostly cloudy skies with light rain. Areas near frontal boundaries are favored locations for enhanced vertical motion, clouds, and precipitation.

Figure 1 – NWS Surface Analysis Chart for 1400 EDT

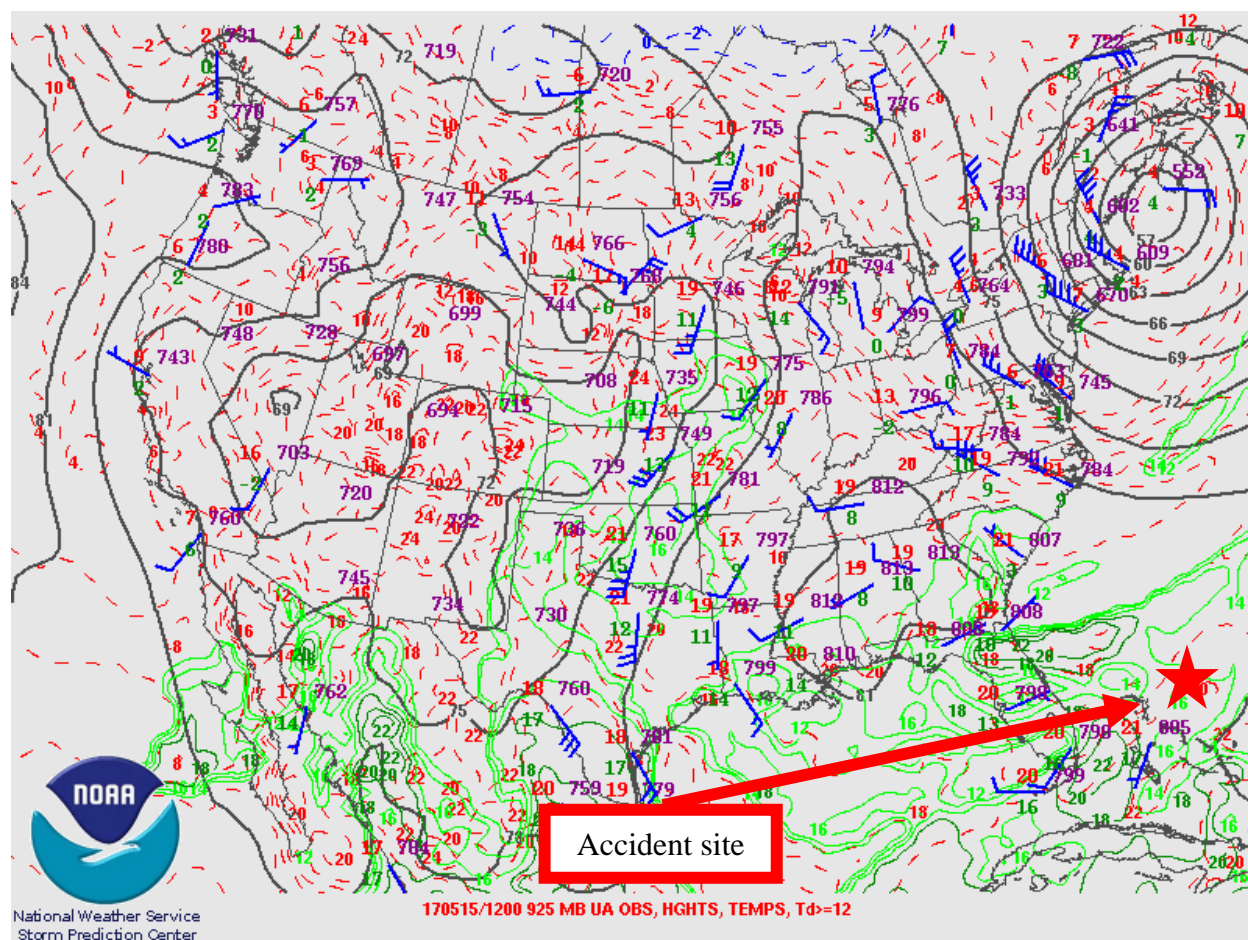
The NWS Storm Prediction Center (SPC) Constant Pressure Charts for 0800 EDT at 925-, 850-, 700-, 500-, and 300-hPa are presented in figures 2 through 6. The accident site was located east of a mid-level trough<sup>2</sup> at 700-hPa (figure 4). Areas near troughs are favored locations for enhanced vertical motion, clouds, and precipitation. This trough was likely the initial starting point of many of the thunderstorms and rain showers on May 15 seen in the weather satellite imagery (section 5.0). There was a southwest to west wind under 15 knots from 925-hPa (figure 2) through 700-hPa (figure 4). By 500-hPa, the wind became westerly at 25 knots (figure 5) with a 65 knot west wind by 300-hPa (figure 6).

Figure 2 – 925-hPa Constant Pressure Chart for 0800 EDT

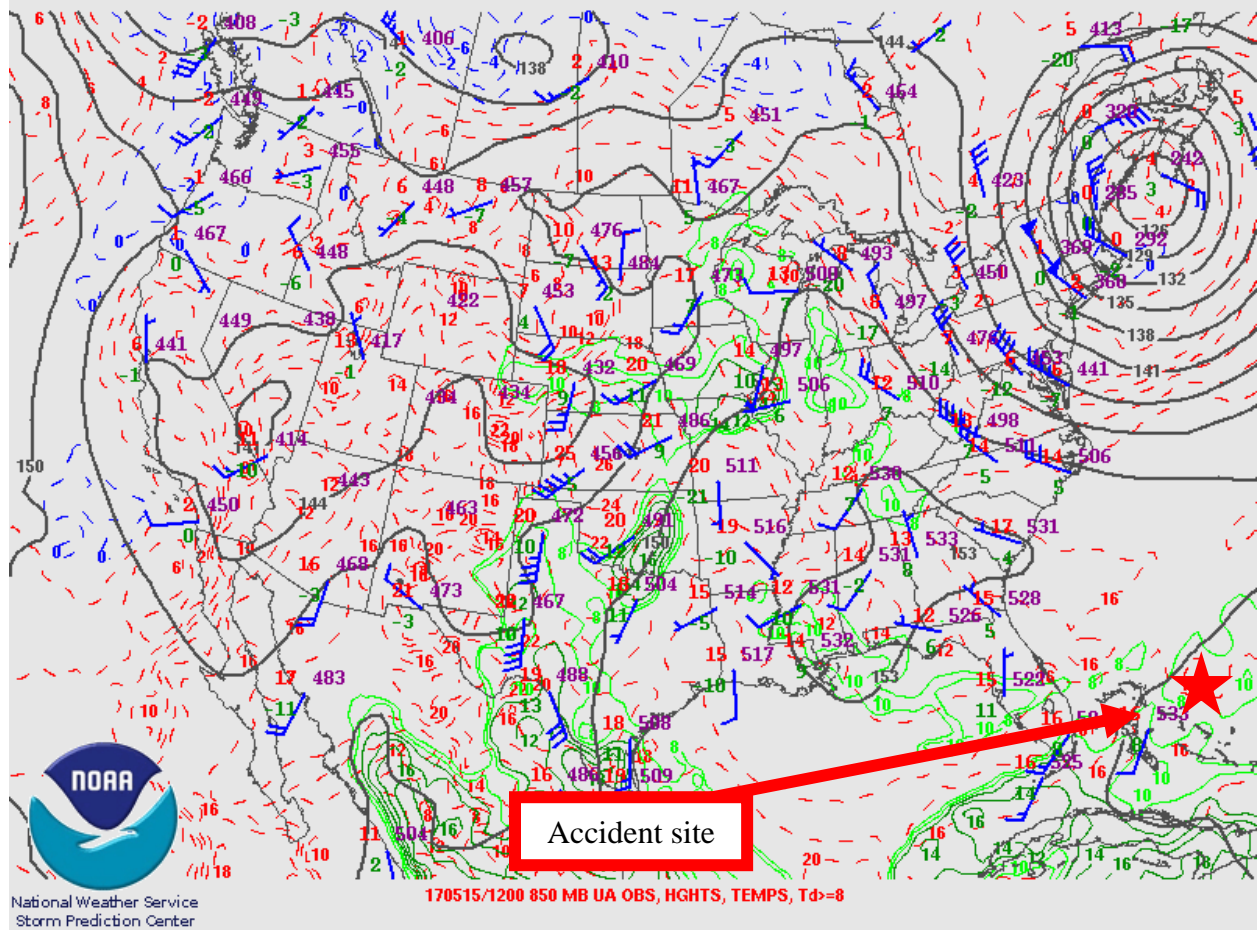
Figure 3 – 850-hPa Constant Pressure Chart for 0800 EDT

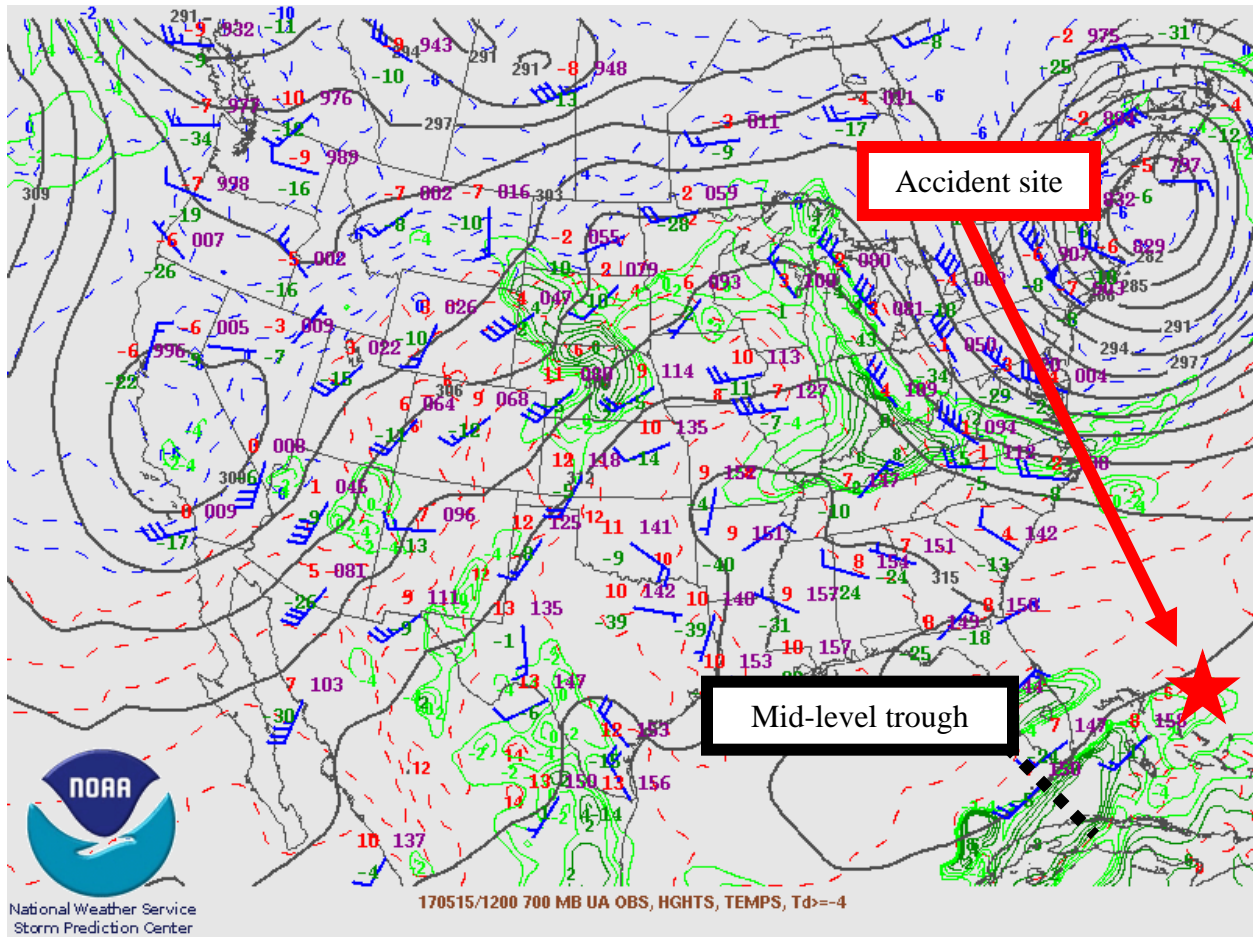
**Figure 4 – 700-hPa Constant Pressure Chart for 0800 EDT**

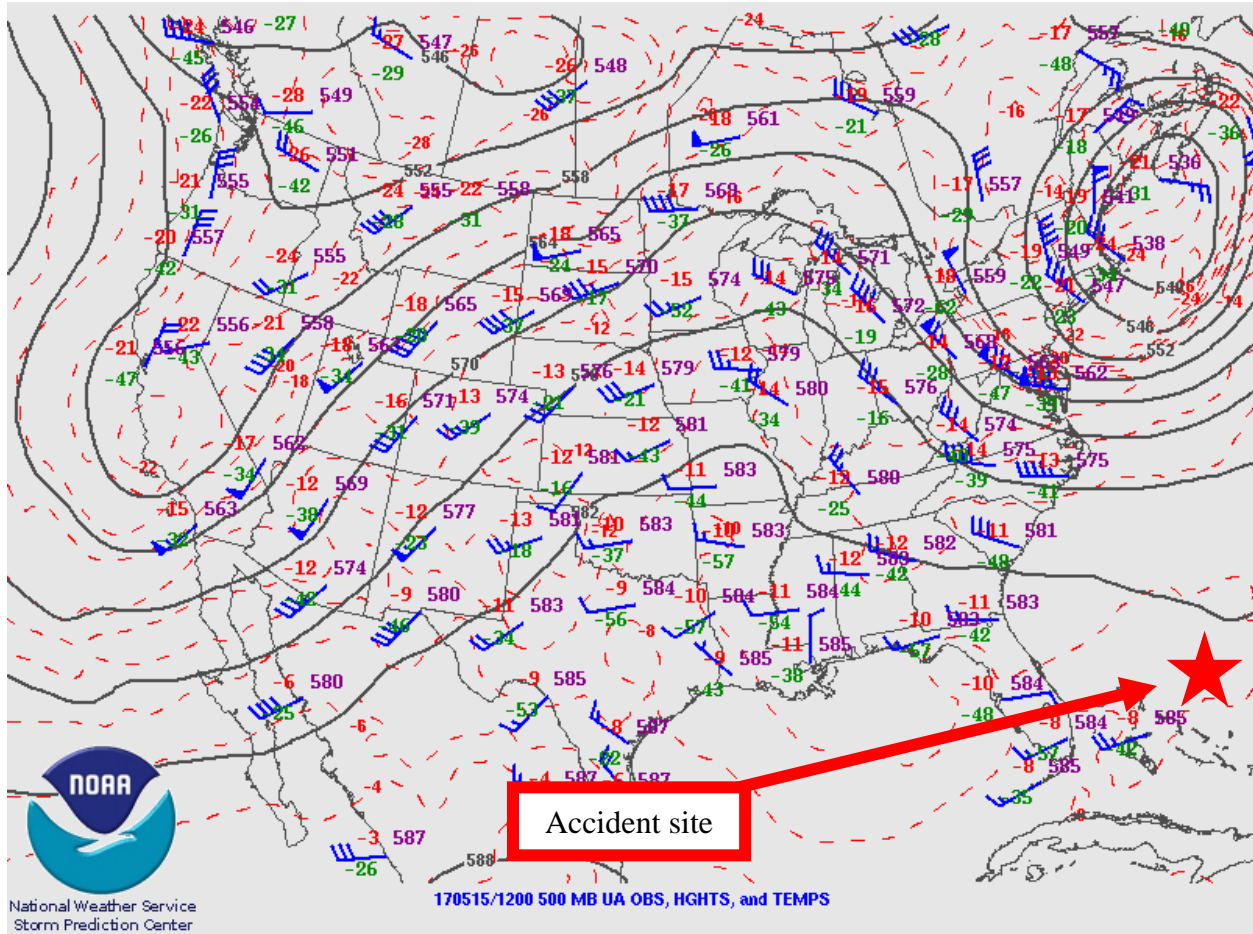
**Figure 5 – 500-hPa Constant Pressure Chart for 0800 EDT**

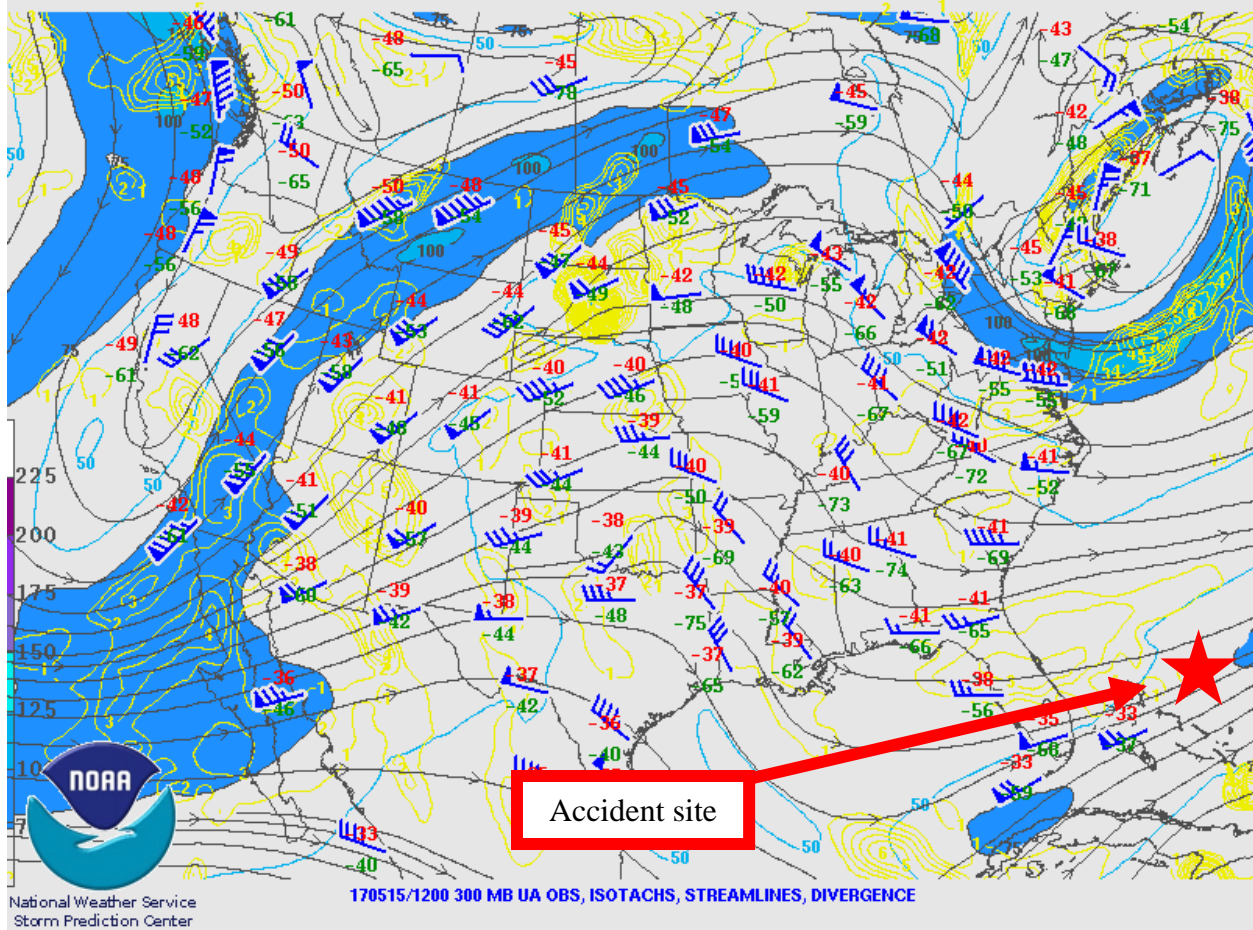
**Figure 6 – 300-hPa Constant Pressure Chart for 0800 EDT**

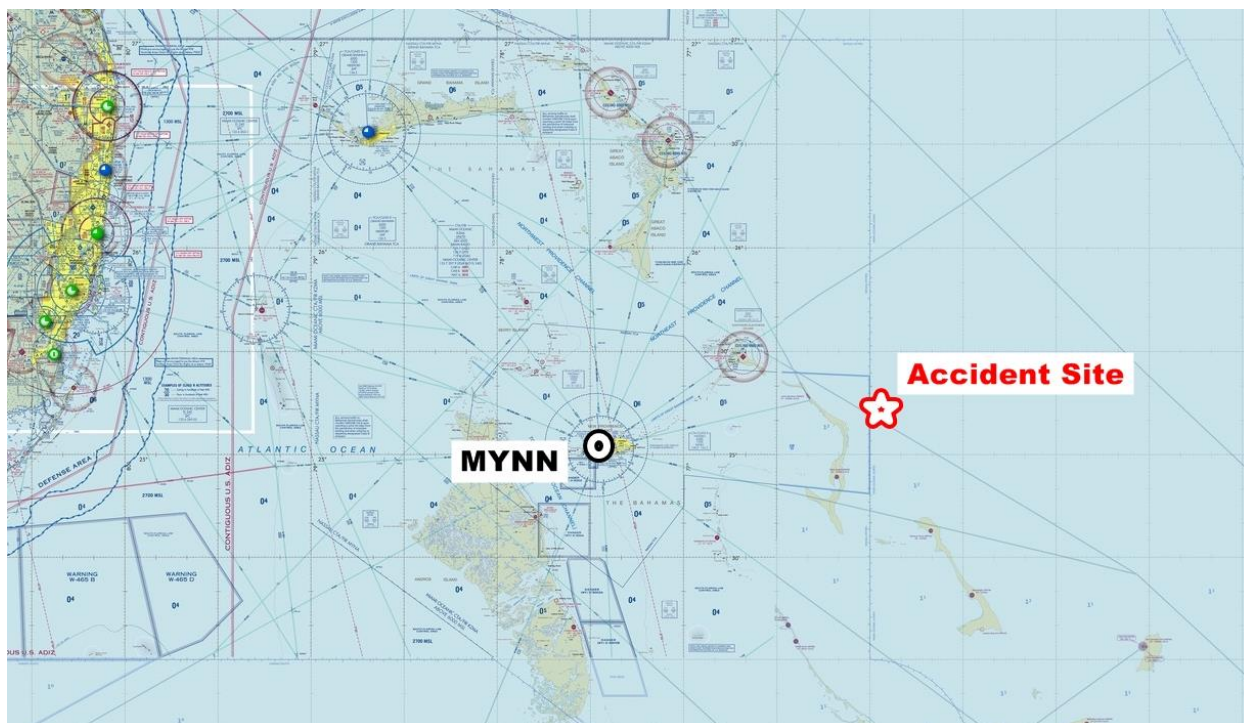
The area surrounding the accident site was documented utilizing official NWS Meteorological Aerodrome Reports (METARs) and Specials (SPECIs). Figure 7 is a sectional chart with the accident site and the closest weather reporting location marked.

**Figure 7 – Sectional chart of accident area with the location of the accident site and surface observation site**

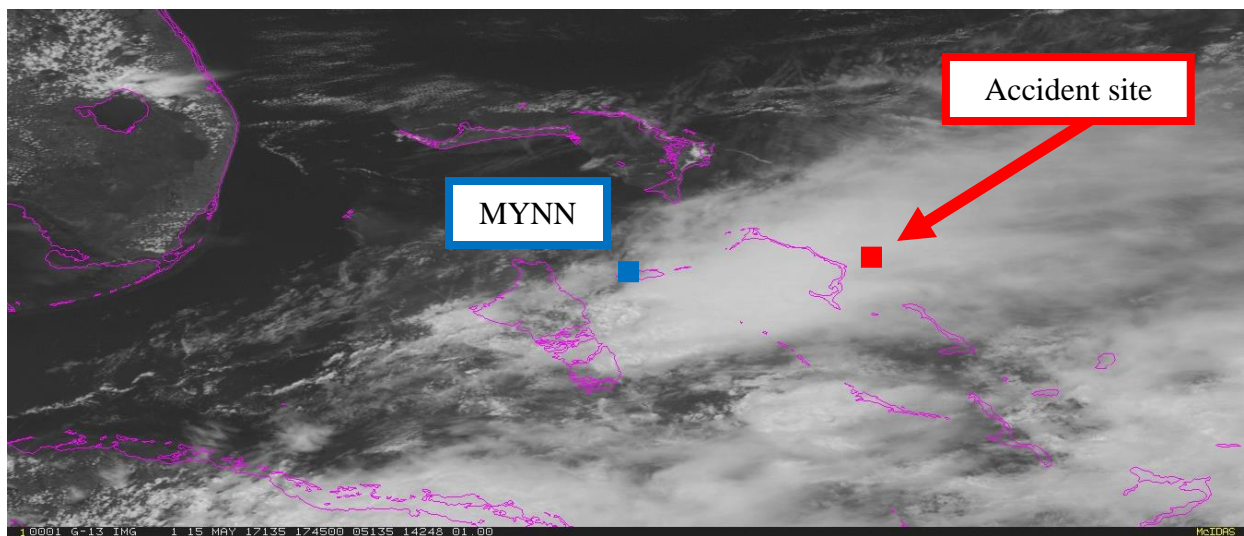
Figures 9 and 10 present the GOES-13 visible imagery from 1345 and 1415 EDT at 1X magnification with the accident site highlighted with a red square. Inspection of the visible imagery indicated abundant clouds over the accident site at the accident time with the cloud cover moving from west to east (attachment 1). Figure 11 presents the GOES-13 infrared imagery from 1345 EDT at 3X magnification with the accident site highlighted with a red square. Inspection of the infrared imagery indicated abundant clouds over the accident site at the accident time with the cloud cover moving from west to east (attachment 2). The lower brightness temperatures (blue and green colors, higher cloud tops) were over the accident site at the accident time. Based on the brightness temperatures above the accident site and the vertical temperature profile provided by the 1400 EDT HRRR sounding, the approximate cloud-top heights over the accident site were estimated at 40,000 feet at 1345 EDT (figure 11). It should be noted these figures have not been corrected for any parallax error.

**Figure 9 – GOES-13 visible image at 1345 EDT**

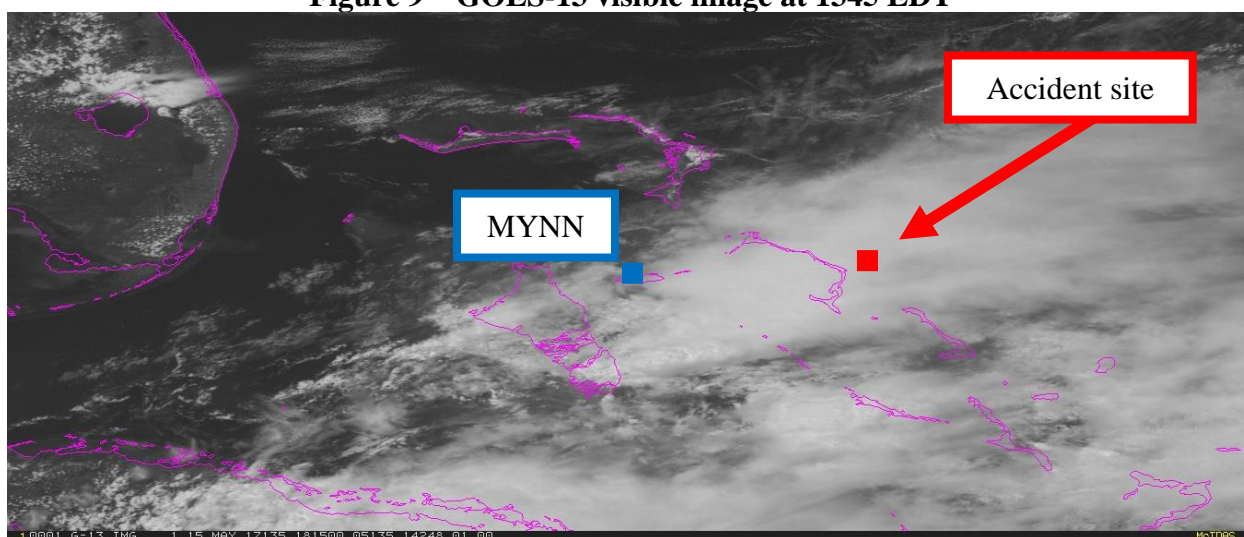
**Figure 10 – GOES-13 visible image at 1415 EDT**

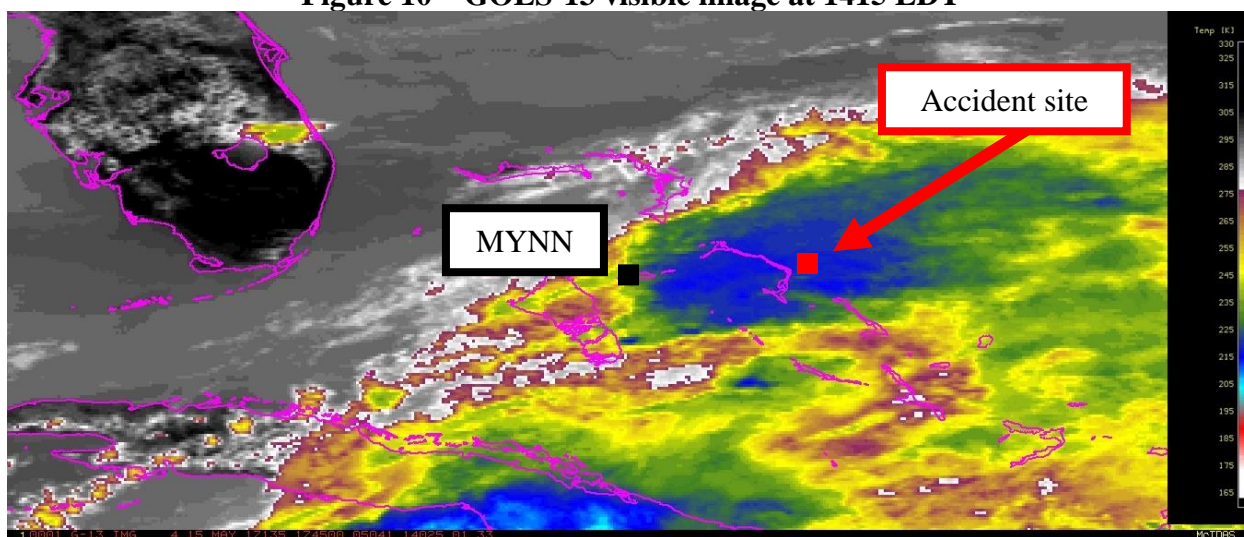
**Figure 11 – GOES-13 infrared image at 1345 EDT**

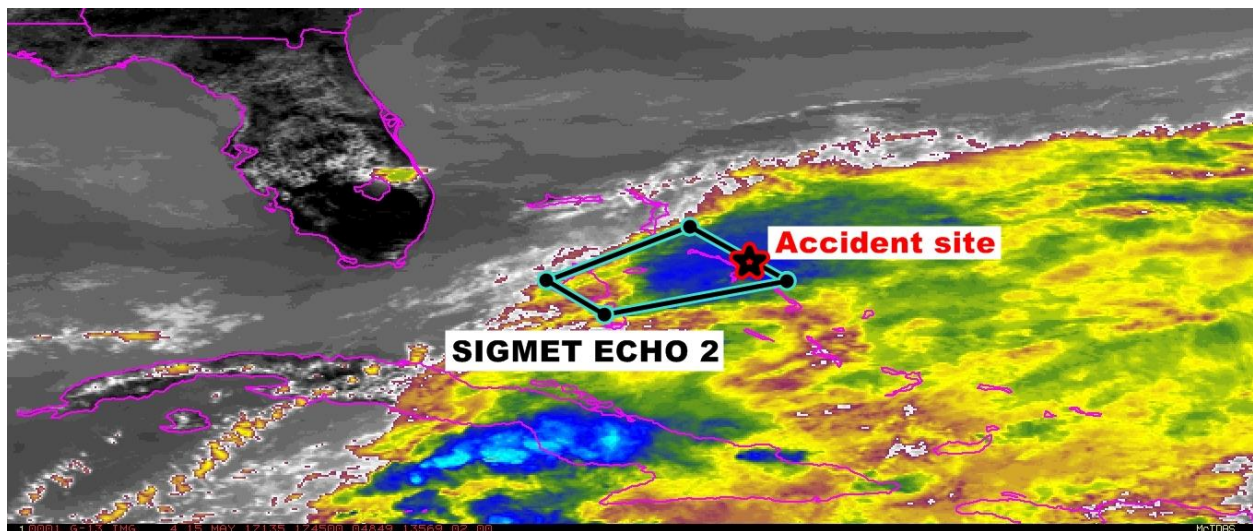
A Significant Meteorological Information (SIGMET) advisory was valid for the accident site at the accident time. The SIGMET was issued at 1300 EDT and valid through 1700 EDT and warned of thunderstorms with tops to FL440 and that the thunderstorms were moving eastward at 25 knots:

Figure 12 – SIGMET valid at the accident time

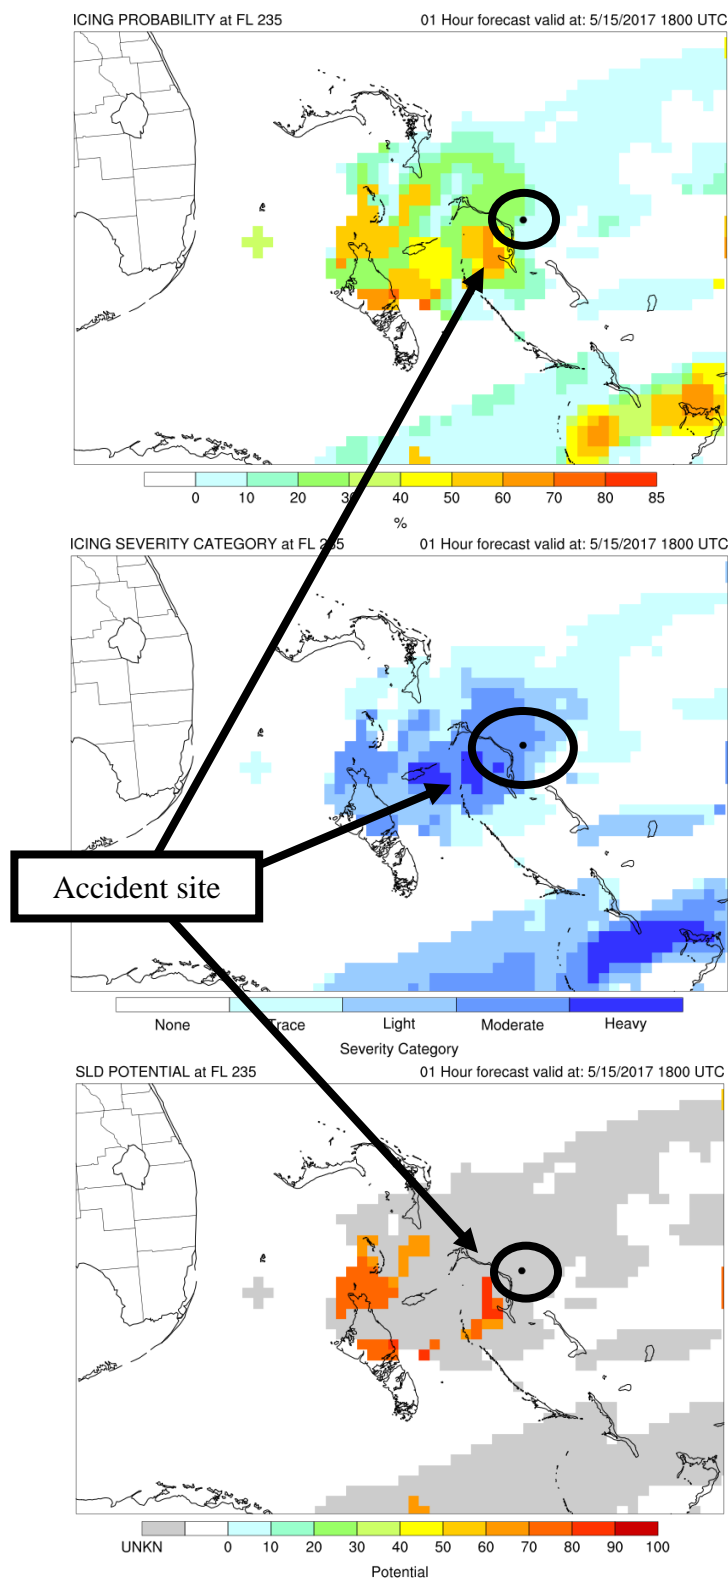
**Figure 13 – (top) FIP probability of icing at 23,500 feet msl, (middle) FIP severity of icing at 23,500 feet msl, (bottom) FIP probability of SLD at 23,500 feet msl 1-hour forecasts valid for 1400 EDT**

Current Icing Potential (CIP) and Forecast Icing Potential (FIP) products are created by the NWS' Aviation Weather Center (AWC) and are intended to be supplemental to other icing advisories (e.g. AIRMETs and SIGMETs). Figures 13 through 15 present the FIP icing probabilities, FIP icing severity products, and FIP Supercooled Large Drops (SLD) potential 1-hour forecasts, respectively, which were valid at 1400 EDT at 23,500, 24,000, and 24,500 feet msl (similar values in the FIP are seen in the 2-hour forecast valid at both 1300 and 1400 EDT, attachment 7). The FIP indicated between a 10 to 30 percent probability of icing at 23,500, 24,000, and 24,500 feet at 1400 EDT at the accident site. The FIP also indicated that the icing near the accident site would likely be moderate to heavy (figures 13, 14, and 15). The FIP did indicate a 70 to 90 percent SLD potential just southwest of the accident area with unknown SLD potential directly over the accident site. This FIP information would have been available on the NWS AWC website before the accident flight departed.<sup>24</sup>

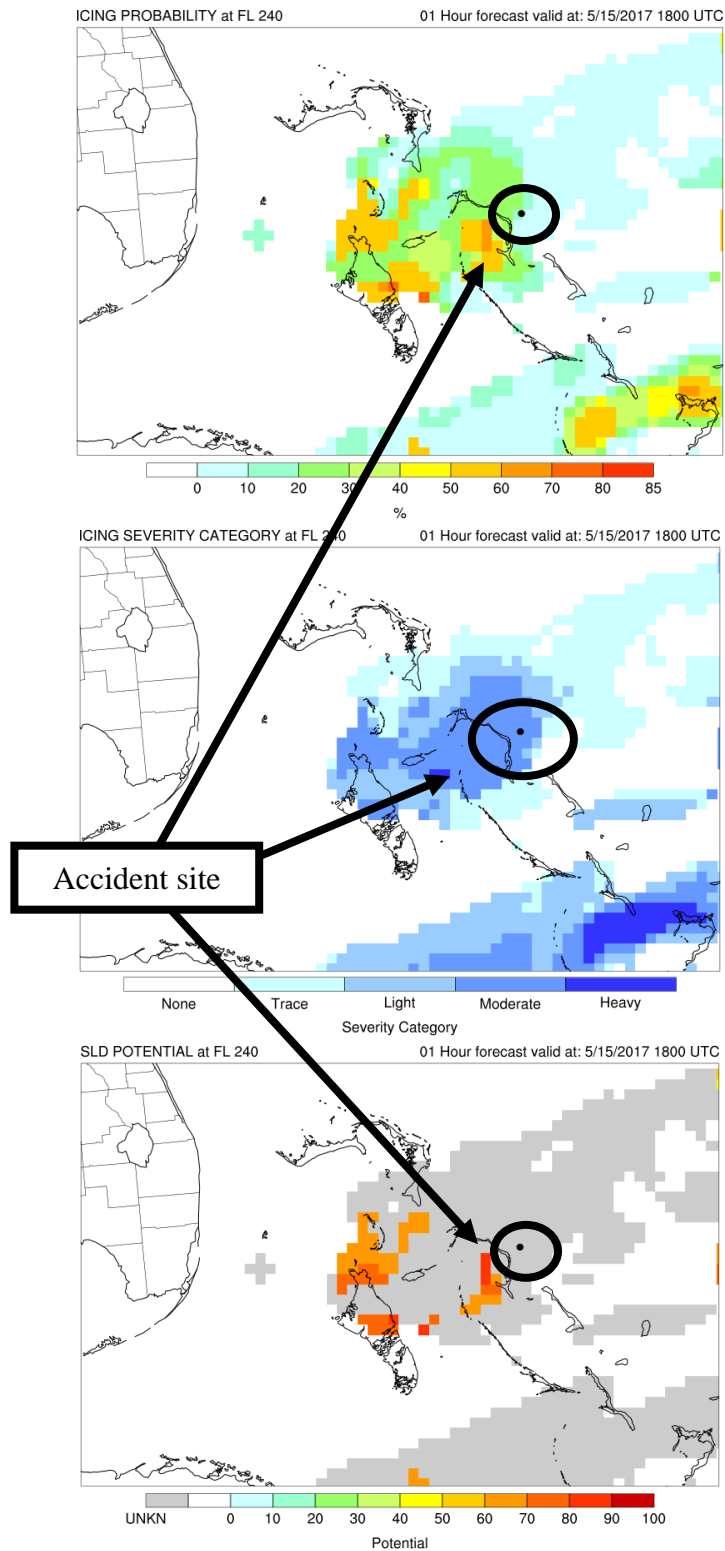
**Figure 14 – (top) FIP probability of icing at 24,000 feet msl, (middle) FIP severity of icing at 24,000 feet msl, (bottom) FIP probability of SLD at 24,000 feet msl 1-hour forecasts valid for 1400 EDT**

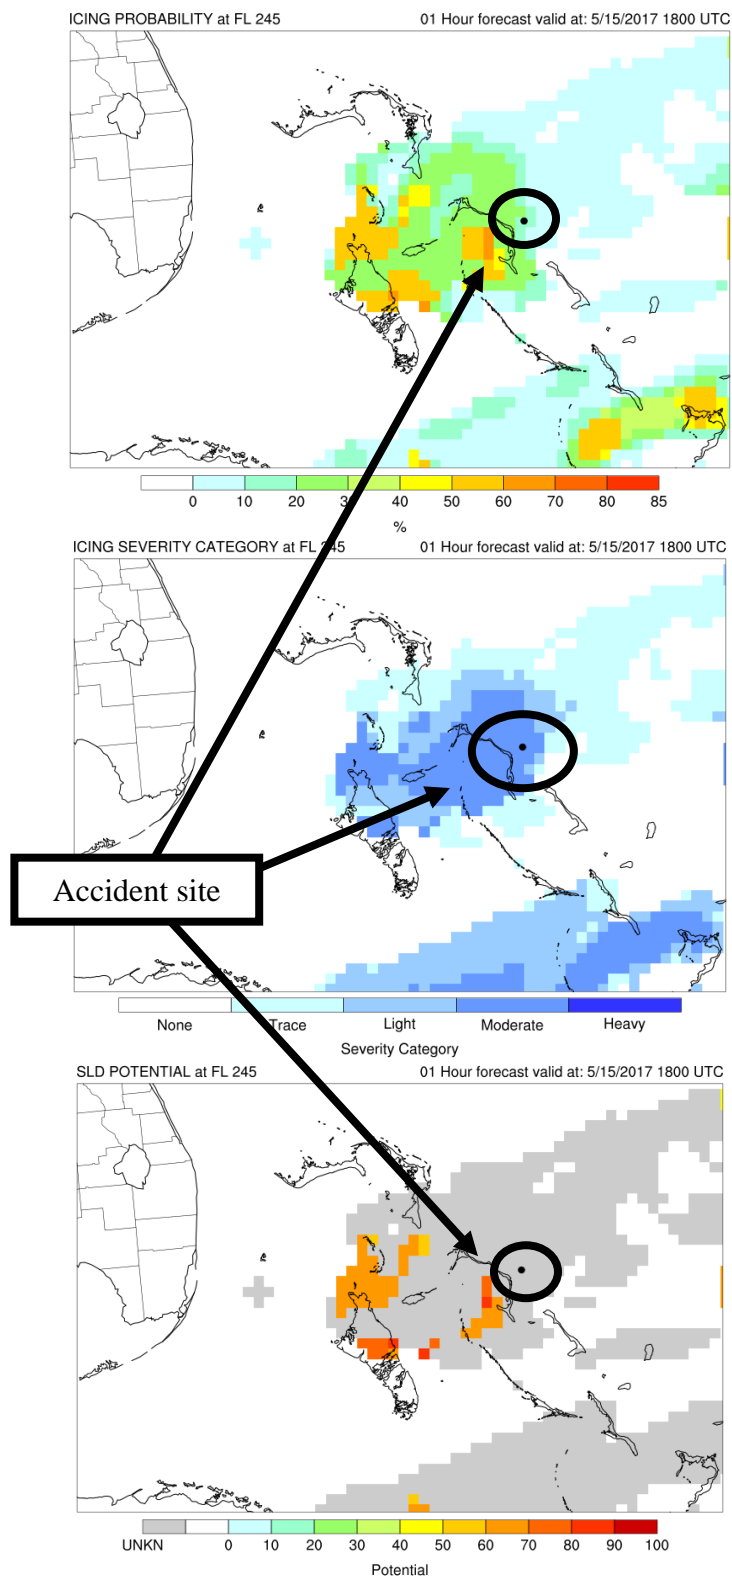
**Figure 15 – (top) FIP probability of icing at 24,500 feet msl, (middle) FIP severity of icing at 24,500 feet msl, (bottom) FIP probability of SLD at 24,500 feet msl 1-hour forecasts valid for 1400 EDT**

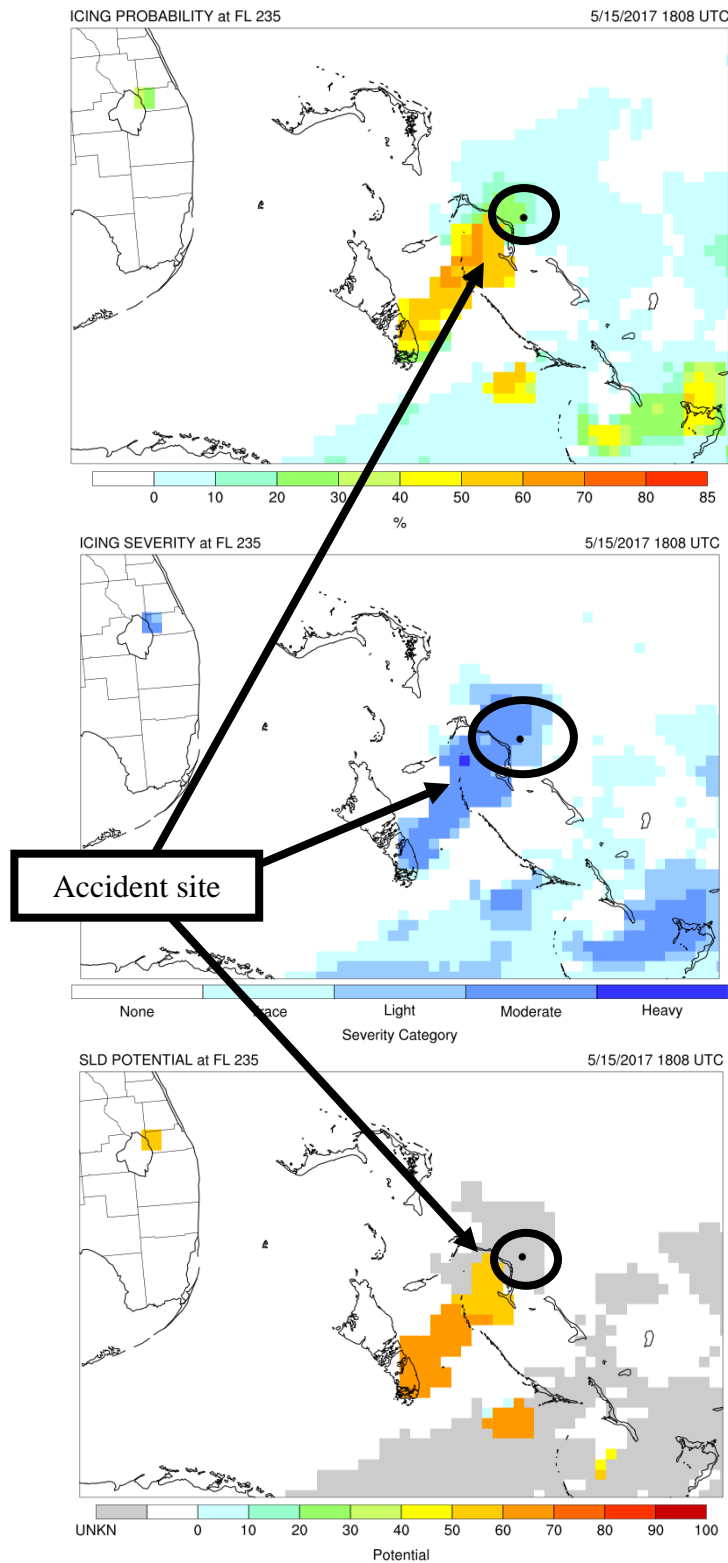
**Figure 16 – (top) CIP probability of icing at 23,500 feet msl, (middle) CIP severity of icing at 23,500 feet msl, (bottom) CIP probability of SLD at 23,500 feet msl valid for 1400 EDT**

The CIP product indicated between a 10 to 30 percent probability of icing at 23,500, 24,000, and 24,500 feet at 1400 EDT at the accident site. The CIP also indicated that the icing near the accident site would likely be of moderate intensity (figures 16, 17, and 18). The CIP did indicate a 60 to 80 percent SLD potential just southwest of the accident area with unknown SLD potential directly over the accident site. While the probability of icing was not high, the FIP and CIP products indicated moderate or greater icing conditions and SLD were likely over the accident area at the accident time (figures 13 through 18 and attachment 7). For more FIP and CIP information and altitudes please see attachment 7.

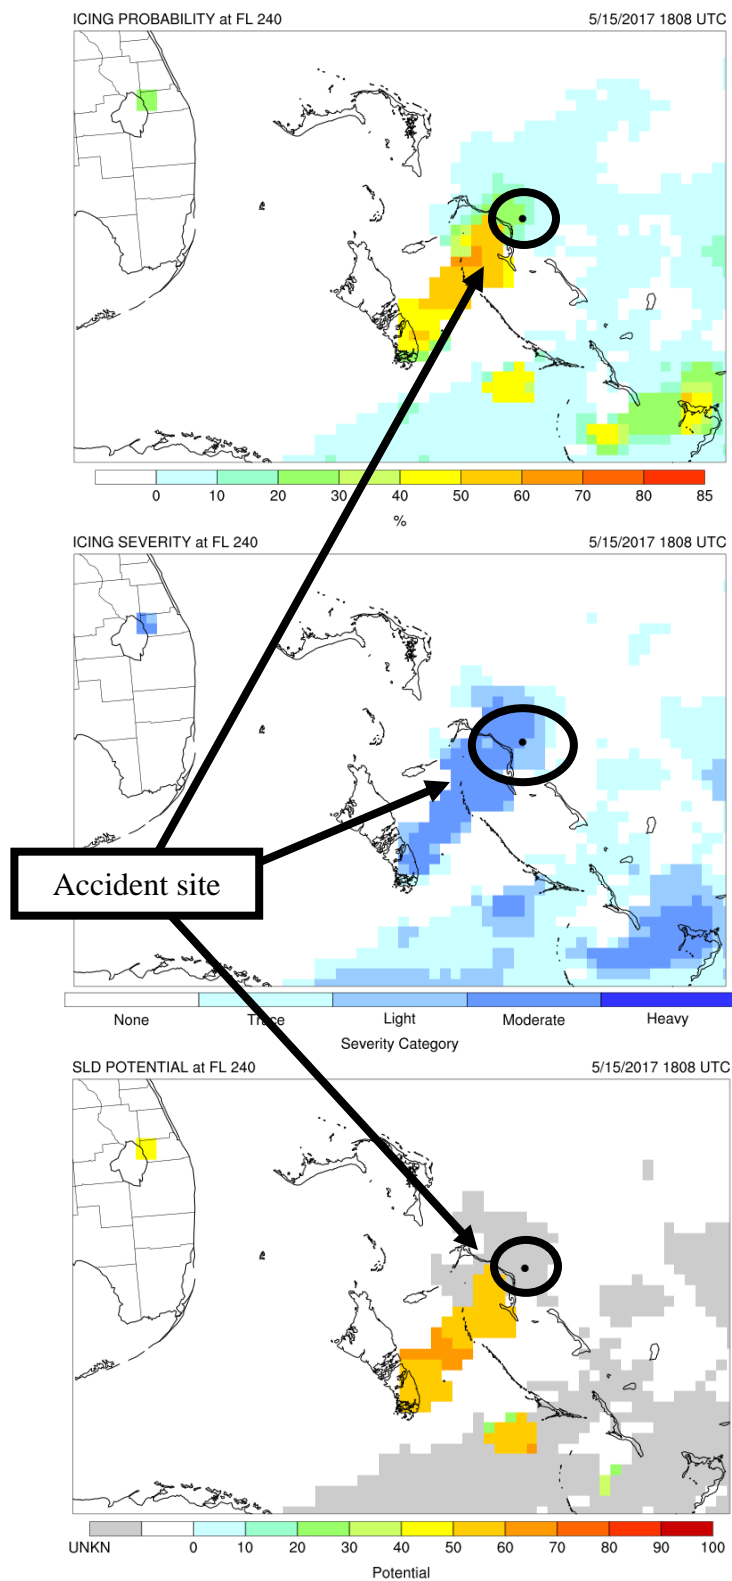
**Figure 17 – (top) CIP probability of icing at 24,000 feet msl, (middle) CIP severity of icing at 24,000 feet msl, (bottom) CIP probability of SLD at 24,000 feet msl valid for 1400 EDT**

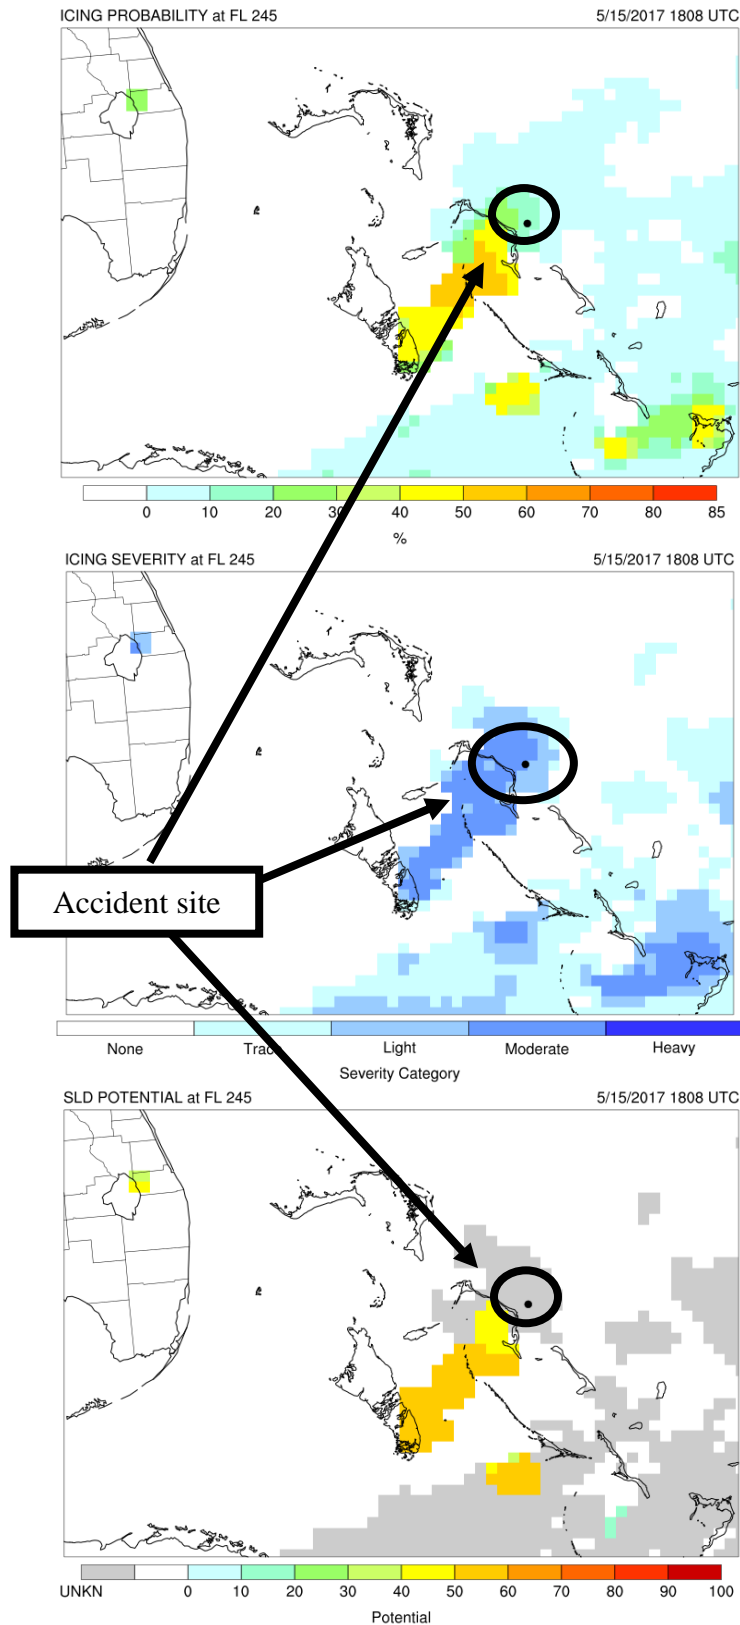
**Figure 18 – (top) CIP probability of icing at 24,500 feet msl, (middle) CIP severity of icing at 24,500 feet msl, (bottom) CIP probability of SLD at 24,500 feet msl valid for 1400 EDT**
